Review & Summary of: Initial Research into the Effects of Woody Vegetation on Levees Volumes I-IV

**By US Army Corps of Engineers, Engineer Research & Development Center
as reported by Corcoran et al. (2011)**

Donald H. Gray & F. Douglas Shields, Jr.
(for the California Levee Vegetation Research Program (CLVRP) Science Team)
December 05, 2011

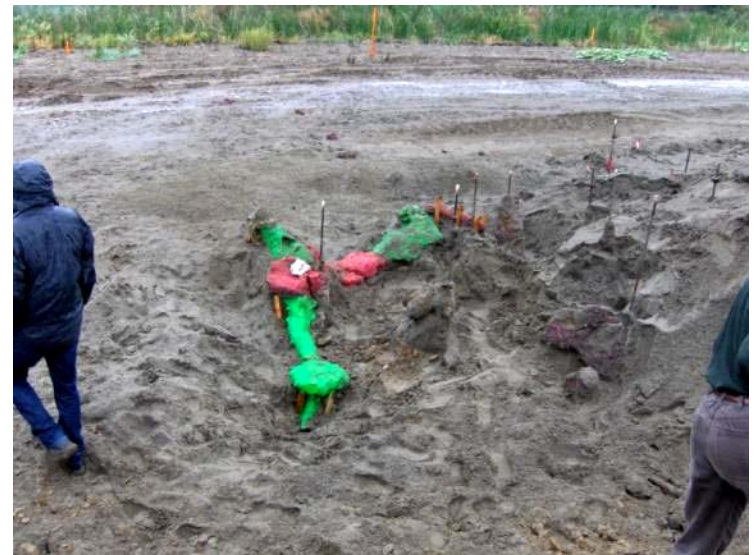
Levee Animal Burrow Impacts

Schematic from Truckee canal failure investigation (US BuRec 2008). Also see Paul and Slaven (2009), Kelley et al. (2009).

Reviewer Note: No examination of woody vegetation/burrowing animal interactions. See graphic next slide.

Recent studies show that animal burrows are a comparable if not greater cause of seepage erosion and hazard to levees than woody vegetation. See ERDC literature review.

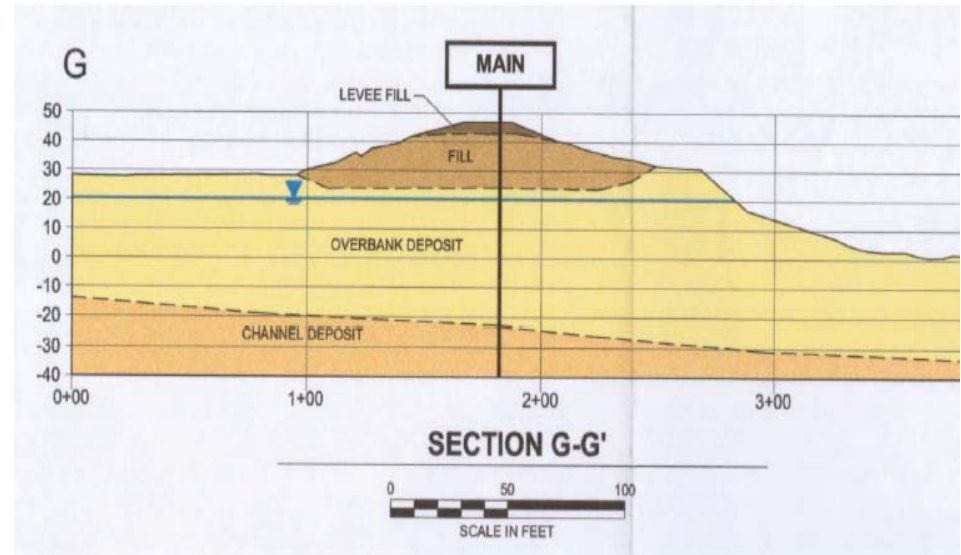
Figure 24b. Cross section G-G' used for the geotechnical evaluation (Golder Associates 2009). Levee fill (dark brown) identified in the bottom profile corresponds to new levee to be added as part of the planned improvements. Only current levee conditions were modeled by FRDC.

- Geological and geotechnical information compiled from existing reports for all sites.
- This information was used to develop representative cross sections for numerical models.

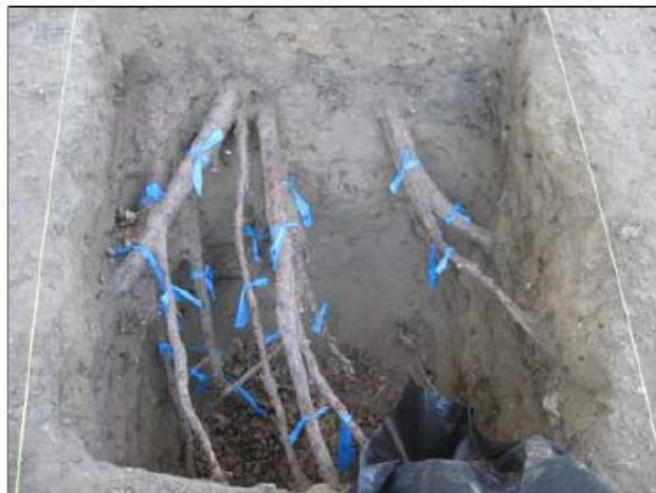
- Subsampled manual excavation of 1 m³ units selected by gridding area around a tree and selecting a subset of grid cells for excavation based on random number generation.
- Subsampled manual excavation root volume ratios 2.5% to 7.8%. Some units very close to trees.
- Sacramento average of 2.5% compares with 0.01% to 2.0% (mean 0.2%) RAR Shields and Gray (1992) for vertical profile wall mapping in driplines.

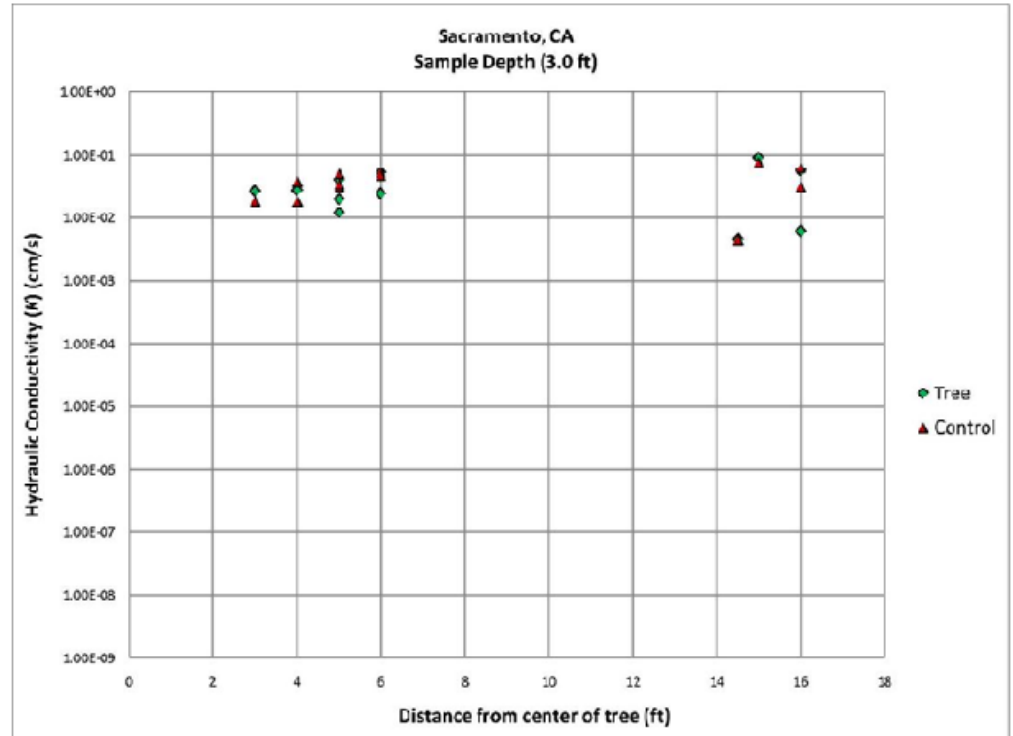
Statistics (areas w/ trees vs. w/out trees) showed no evidence that tree roots influence the average hydraulic conductivity of a soil layer.

Figure 222a. Hydraulic conductivity calculated from in situ permeameter tests at a depth of 3.0 ft, Sacramento, CA.

(Pg iii) "Only one test showed evidence of an existing macropore associated with a tree site."

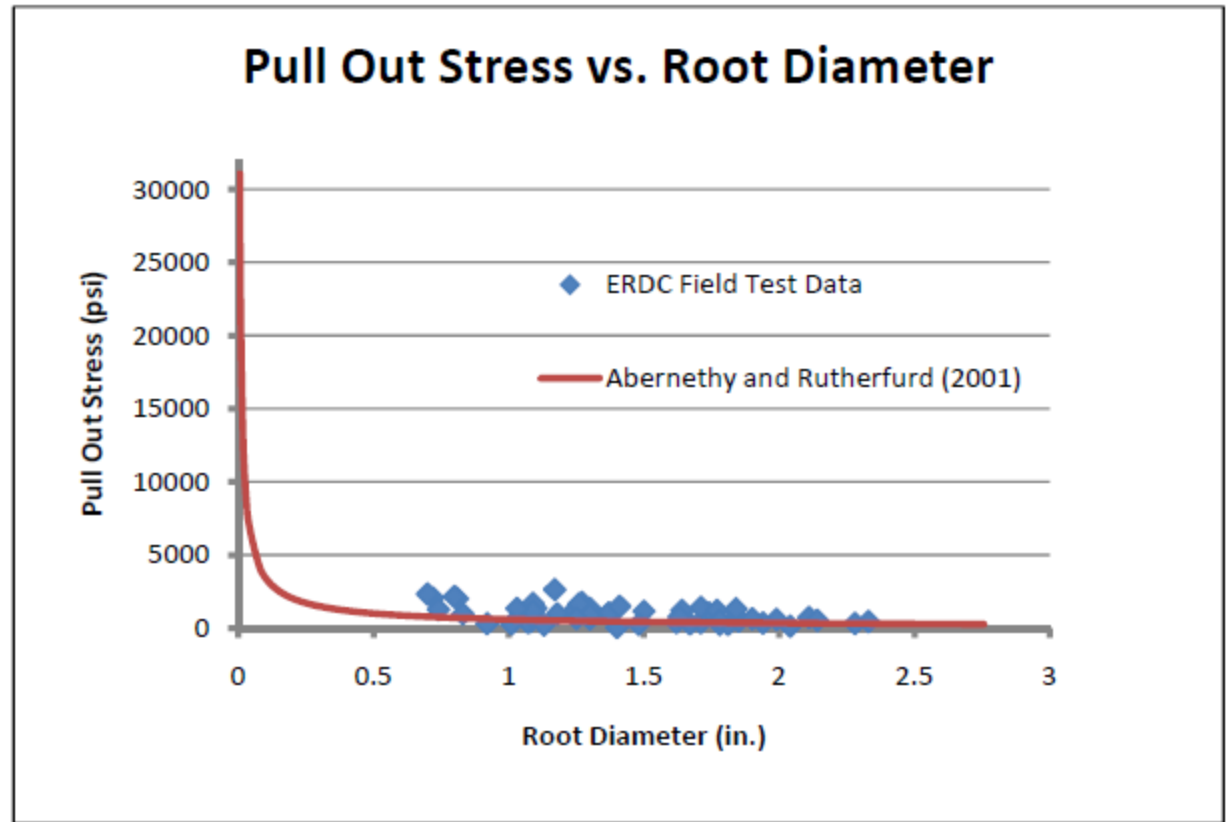
Figure 251. Comparison of ERDC and Abernethy and Rutherford (2001) pullout stress vs. root diameter tests.

Reviewer Note: Use of root pullout strength reasonable because failure tended to occur by slip or pullout.

- Tested roots in narrow range of larger diameters 0.7 in to 2.5 in. No effect due to species, but location and diameter were important.
- Work by others shows small roots (< 20 mm diam) have large contribution to soil strength at least at shallow depth.
- Root pullout strength (force required to pull root out of soil), not tensile strength (force required to break a root), was used in numerical slope stability analysis.

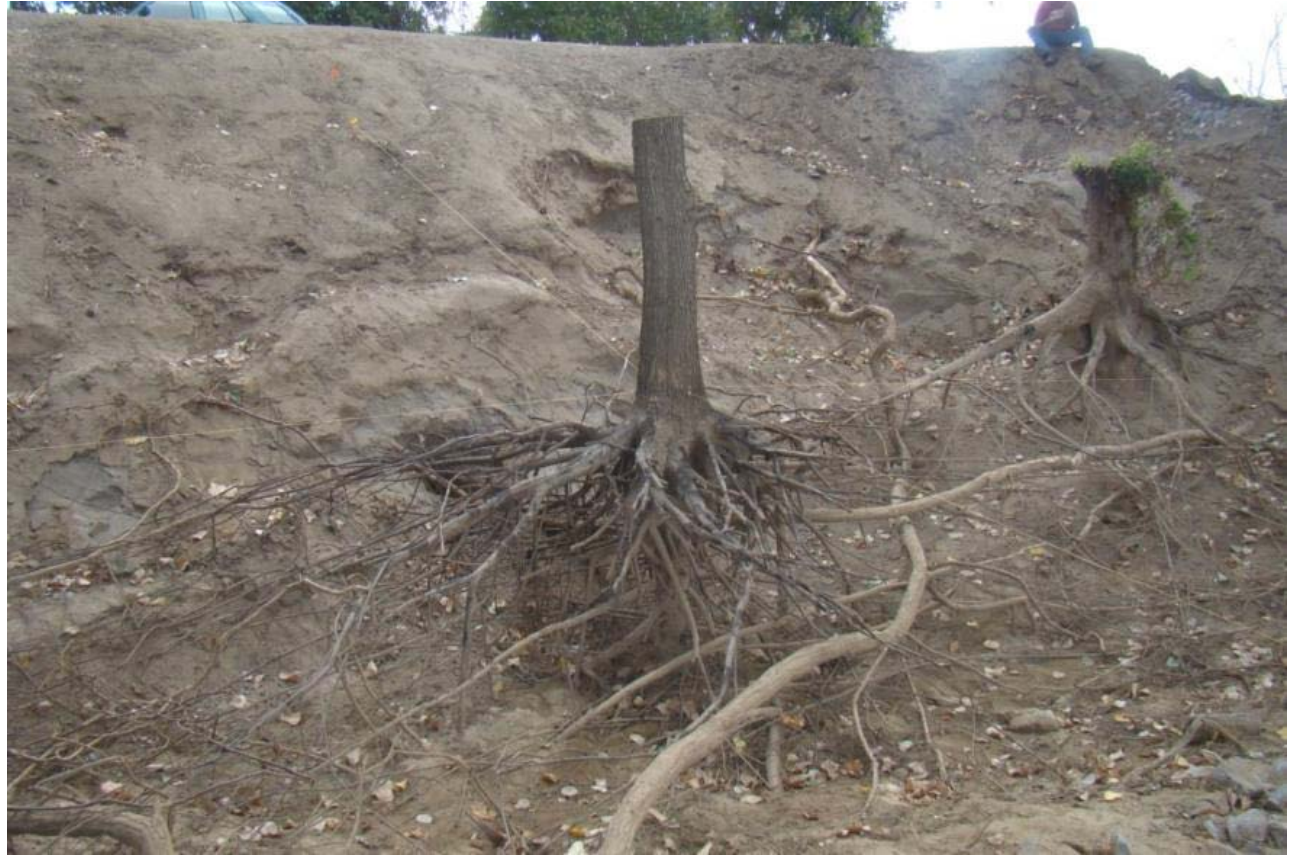
Compare “rectangular block” with root architectures exposed by Dr. Alison Berry

(Photo CLVRP 2010)

(Pg. iv) “The extended root system was depicted as a uniform area of low hydraulic conductivity, which is an extreme representation that may not reflect actual field conditions.”

Reviewer Note: Many root distribution studies have reported root densities decline exponentially with depth below soil surface.

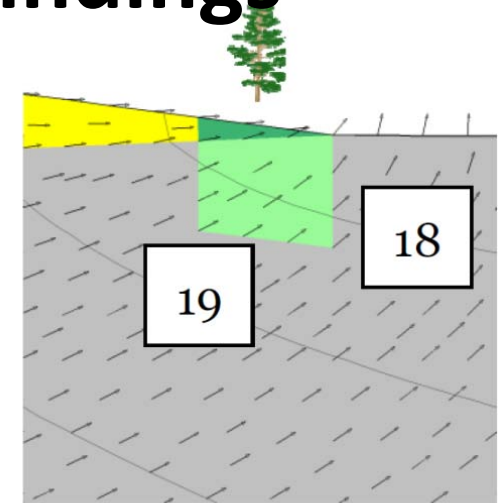
(b) $\beta = 1$ ($k_{veg} = 1 k_{no-veg}$).

- Sensitivity analysis
- The volume around a root zone was assigned various values of hydraulic conductivity (varied across 4 orders of magnitude) with conditions within the zone assumed uniform.
- Root zones generally affected the flow field within their immediate vicinity, but have virtually no influence on the overall flow field.
- The most likely impact on the flow path or critical gradient occurred when the tree was located at the toe of the levee, but this impact depended on the degree to which the tree altered hydraulic conductivity of the soil.
- Changes in hydraulic conductivity on the riverside do not appear to affect the landside flow conditions.

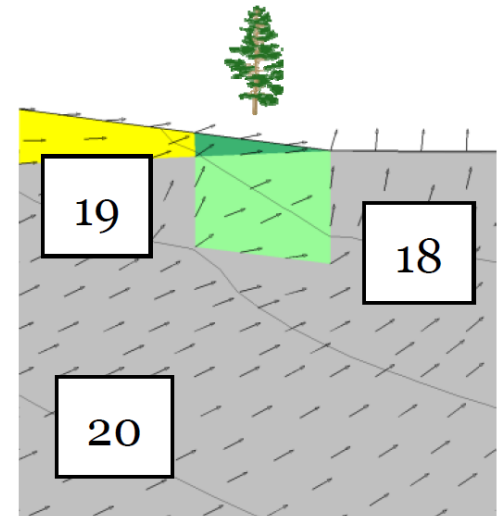
(h) $\beta = 0.01$ ($k_{veg} = 0.01 k_{no-veg}$). → 1

“The case where the root system causes a reduction in hydraulic conductivity by more than a factor of 10 shows an increase in hydraulic gradient as a result of low hydraulic conductivity of the root zone blocking the flow of water.”

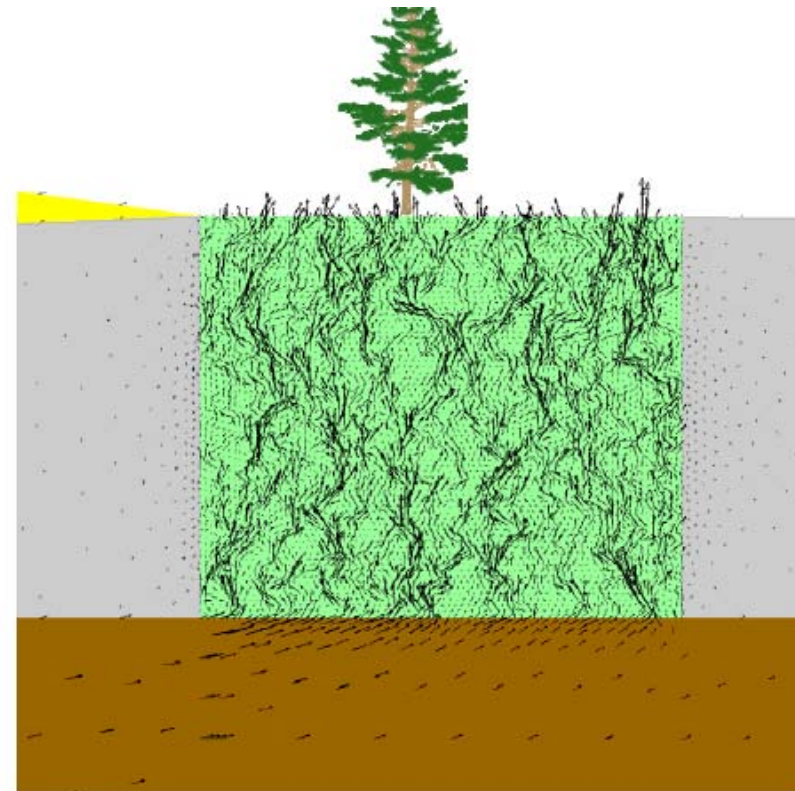
Vectors in root zone larger than for surrounding soils (Pg. 137-138).

- Representation of vegetation influence as randomly distributed hydraulic conductivity within the block-- “macropore heterogeneity”.
- Resulting seepage velocity vectors show that a random heterogeneous zone can have flow paths that support large flow velocities.
- (Pg. iv) “However, research does not exist on whether high velocities result in the initiation of internal erosion.”

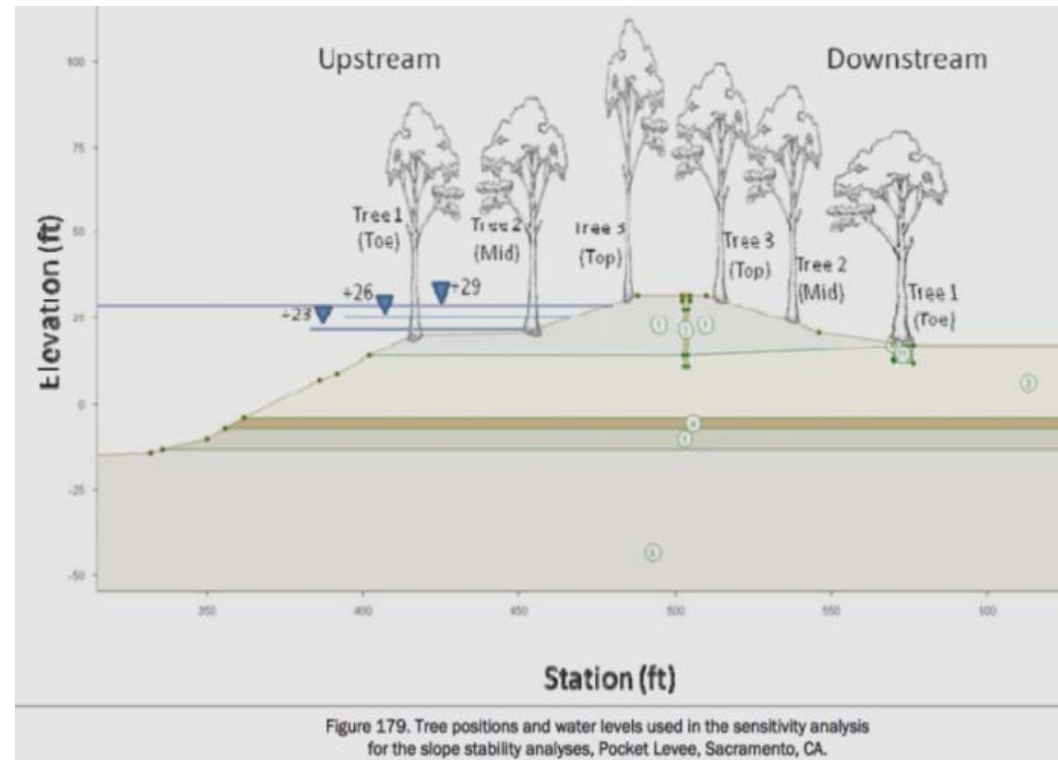
(Pg. V) “In general, this study observed that trees on the upper part of the slope decreased the factor of safety because they add weight. Trees near the toe increased the factor of safety because of the reinforcing effects of the roots and the increased counterweight effect of the tree to slope movement. Trees at midslope had lesser effect on the factor of safety because they acted as a load, but not a counterweight, and the roots are too shallow to reach the failure zone within the midslope region”.

Reviewer Note: Similar findings reported by Norris and Greenwood (2006) and by Danjon and others prior to this study.

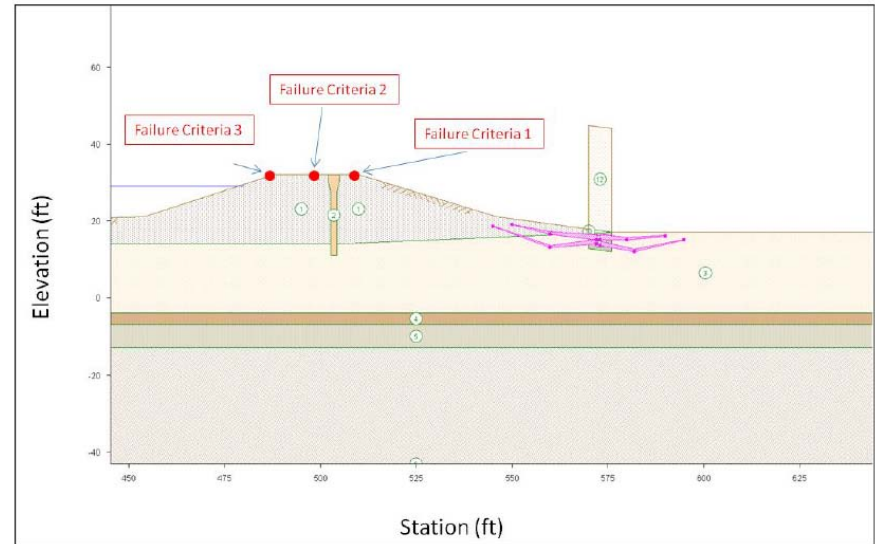
Figure 175. Three failure criteria used for calculating the factor of safety on the landside at the Pocket Levee, Sacramento, CA.

“To gain an understanding of how the tree position affected overall levee stability, three failure criteria were defined by limiting the software’s search routine to failure circles passing through three points (Figure 175). These limitations are designated as failure criteria because they determine which factor of safety value is identified as being closest to failure. While this procedure may not find the absolute minimum factor of safety for a given slope, it will serve as definitive criteria for quantifying the effects of trees on levees.”

Reviewer note: Probably reasonable approach for the problem at hand, but slope failures in sandy soils tend to be shallow, planar failures and root reinforcement will likely have greater positive impacts on shallow failure zones (Shields and Gray 1992).
